INVESTIGATING COMMUNITY RESILIENCE IN CHAUTARA, NEPAL

Abstract

Keywords: reconnaissance, resilience, Chautara Nepal, 2015 Gorkha Nepal earthquake

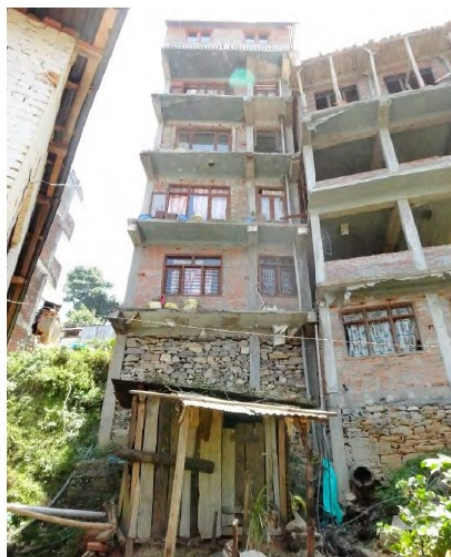
(a)

Fig. 1—(a) Rear view of RC frame with masonry infill building in Chautara showing the down slope side; note stone infill at lowest story (photo: Bret Lizundia), and (b) damaged buildings in Chautara showing spray-painted marks indicating postearthquake safety evaluation status (photo: Hemant Kaushik).
