Characterization of landslide and its earthwork solutions

A Rochim* and Pratikso

Civil Engineering Department, Universitas Islam Sultan Agung, Semarang, Indonesia

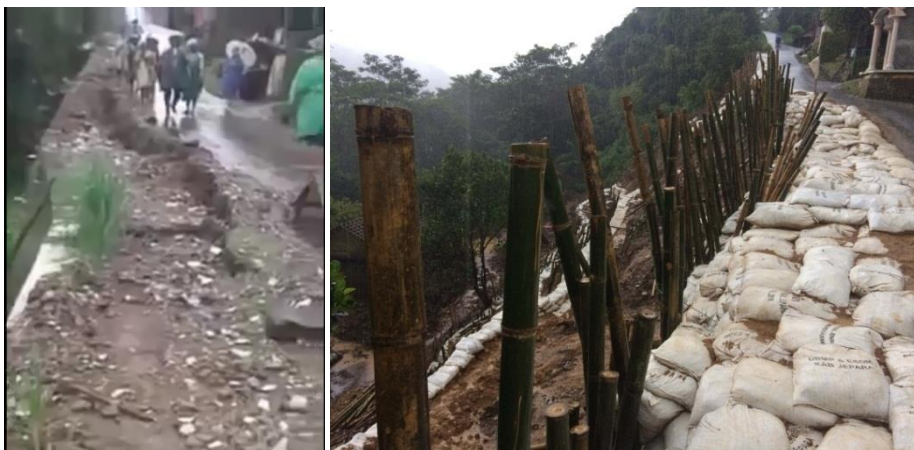
In the first part, condition of before - after landslide, road condition, and drainage are explained. Fig. 1 and Fig. 2 present before and after landslide condition, and the drainage respectively. The height of slope from the toe to the road is around 20 meters. From Fig. 1 left-side condition before sliding, the counterfort (gravity wall) constructed has steep slope almost vertical (approximately 1: 0.1).

Figure 1. Before and after landslide condition

The existing slope before sliding is taken from video on internet. After landslide, the slope is around 1:1 which the landslide reaches the houses. The road using flexible pavement is 3 meter wide, only light vehicles can pass by. It is impossible for two cars standing side by side due to the width of the road. Fig.2 displays the drainage condition. It seems that drainage is not well managed since water infiltrates to the soil. Landslide occurred when it rained.

- 1) The height of slope is very high around 20 meters with angle of slope near - vertical gradient. With such height, the gravity wall type counterfort constructed has steep slope almost vertical (approximately 1: 0.1) and without flat surfaces or platforms. Drainage is not well managed causing water easily infiltrates to the soil. The slope is composed of fairly good soil with consistency Silty Sand (SM) with high friction angle. However mobilized stress coming from external loads was higher so that landslide occurred. From this findings, the reinforcement of gravity wall cannot bear the loads coming from infiltrated water, road and building loads. The slope with height is 20 meters without a terrace, installing gravity wall is not good choice.

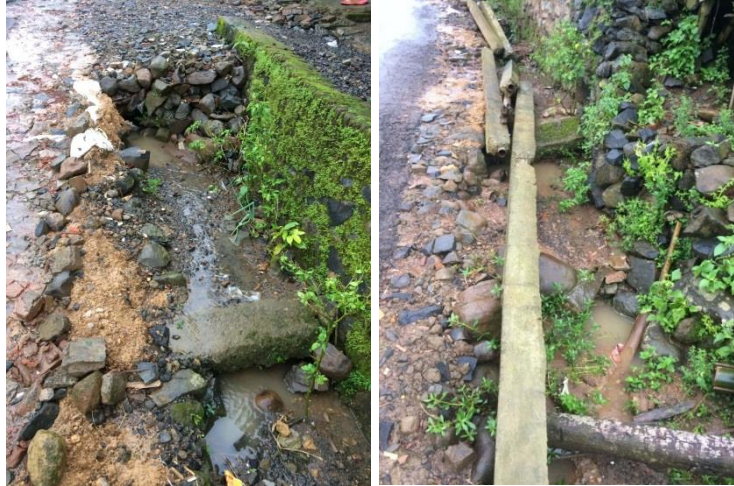
Figure 2. Drainage condition

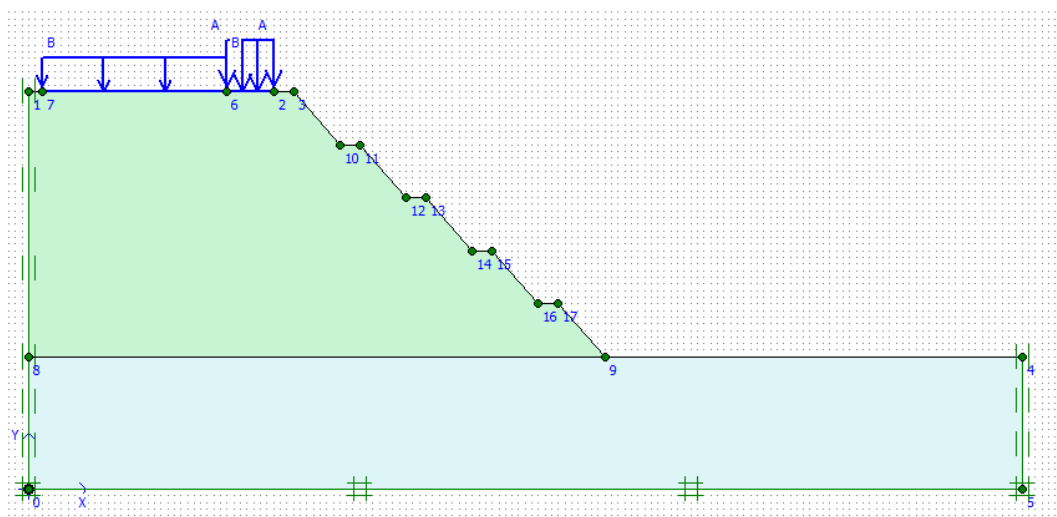
Some earthwork solutions which propose sufficient stability can vary. However, for economical purpose, available space, and the easiness of construction they cannot be applied since they are very costly. Compared soil reinforcement to modification of slope angle, the latter is somewhat more efficient. Like displayed in Fig. 4, slope is modified into 5 terrace model having slope 1:1 each terrace. This modification results SF 1.56 more than 1.5. The deformation presented in Fig. 5 reaches highest on the horizontal surface (red color) not in slope. However this model requires large space to construct soil embankment.

Figure 4. Terrace earthwork solution without reinforcement

- 2) In order to have a stable slope, firstly external loads should be taken into account in existing condition to find out whether landslide occurs or not. Soil is modeled as saturated soil not as dry soil. From Plaxis, the SF of slope without reinforcement is only 0.61, then after the slope is reinforced with gravity wall, the SF is 1.01 less than 1.5. For economical purpose, earthwork solution can be proposed by modification of slope angle. With the slope contains 5 terraces having slope 1:1 each terrace, the SF 1.56 more than 1.5.
